## Maryland Department of Environment

**Site Name:** Kilby Farms LLC / Hartland Holdings LLC  
**Facility Address:** 785 Fire Tower Road, Colora, MD 21917  
**County:** Cecil County

**Inspection Date:** October 5, 2026,

### Field Inspection Report

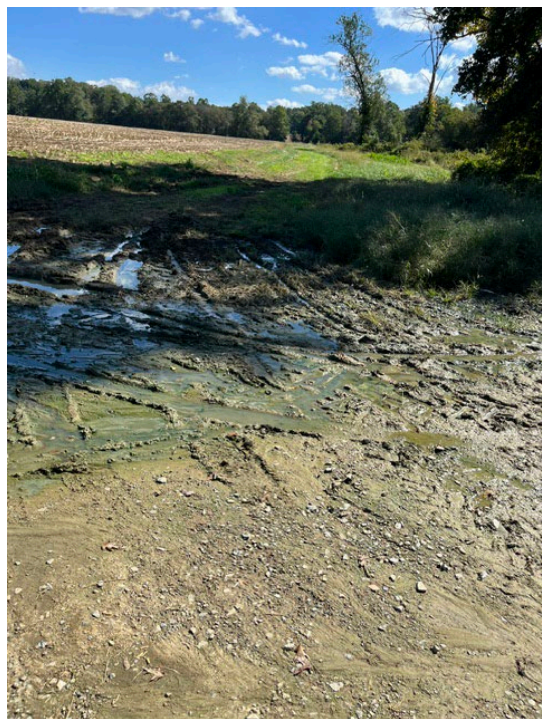
Bottom of the hill just before Basin Run. This is where the processed wastewater pools downhill from the concrete pad where the calf hutches reside.

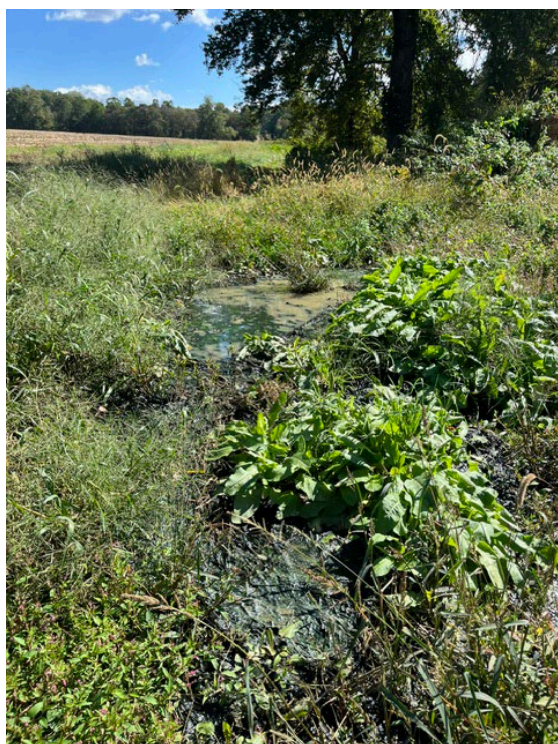
The slurry of manure, leachate, and wastewater pooled approximately 100 feet from Basin Run

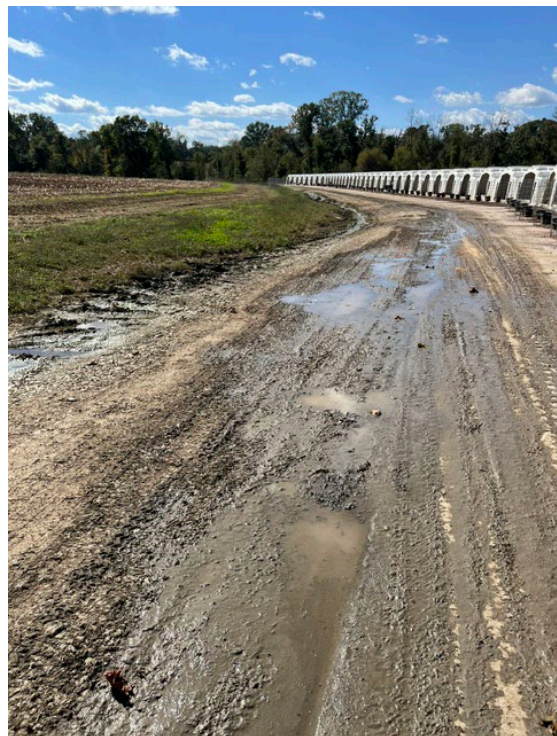
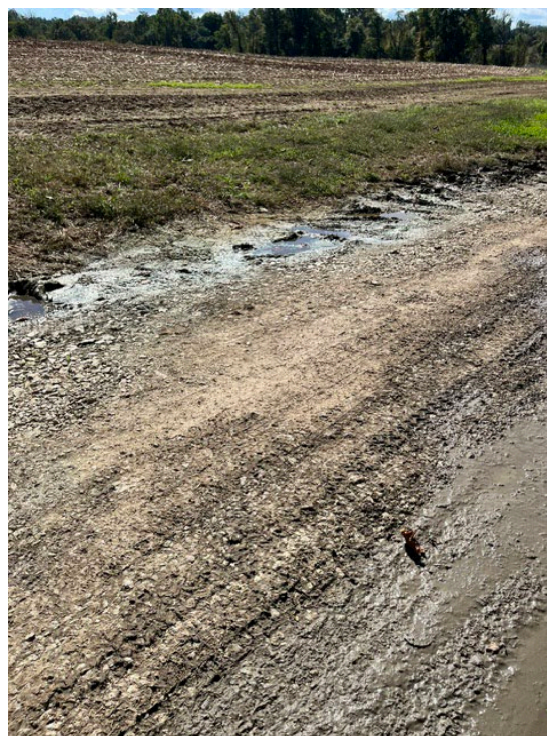
Higher up the hill on the concrete pad the calf hutch, notice the wastewater traveling south and downhill towards Basin Run. There are no BMP's to collect this mixture of processed wastewater and manure before reaching Basin Run.

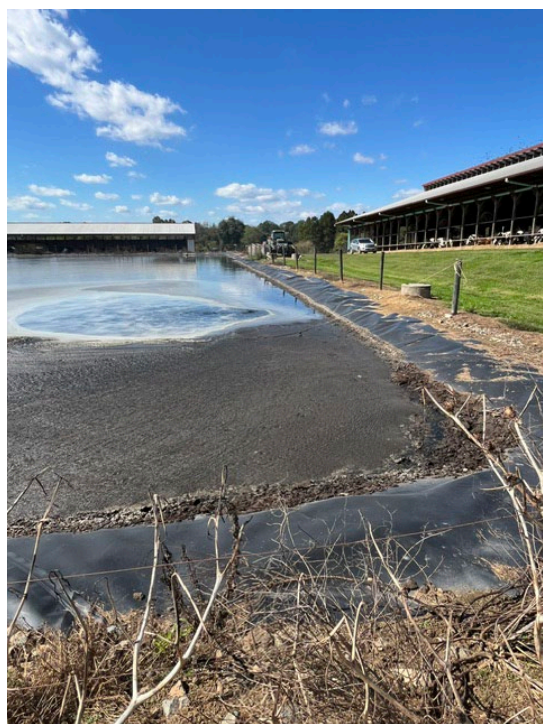
Manure pitd # 1 at maximum capacity

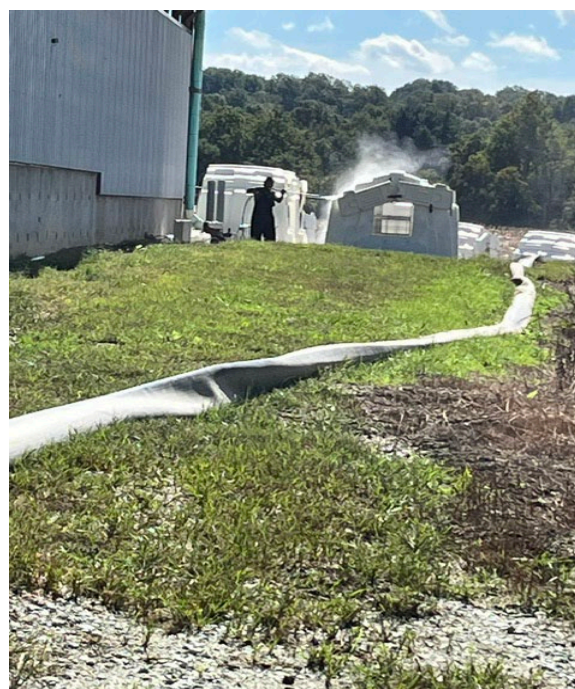
Farm worker power washing calf hutch which creates process wastewater which washes down the concrete pad and eventually into Basin Run.

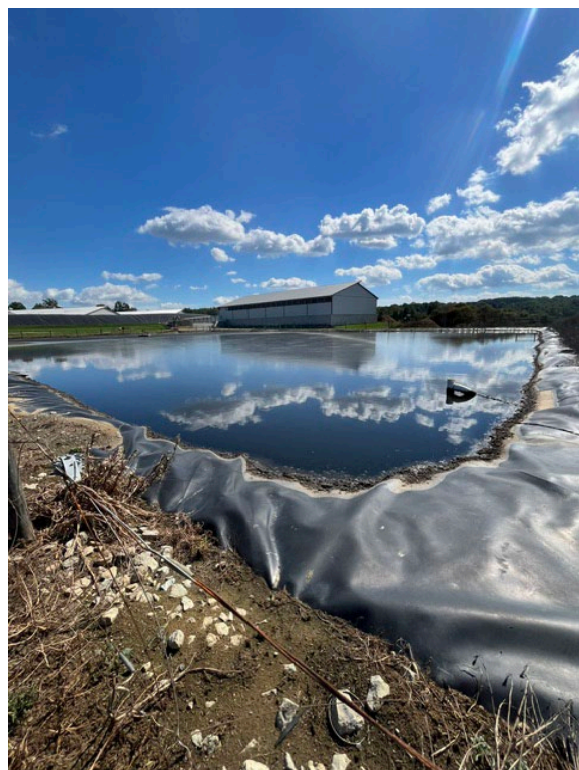
Manure pit #1 at maximum capacity.

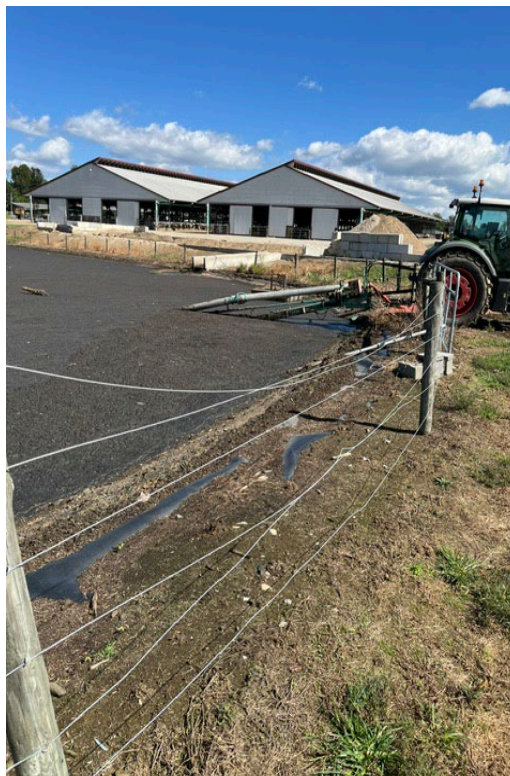
was full and at maximum freeboard level. Page 17, paragraph 2 of the permit requires animal waste levels to remain at least 12 inches below maximum depth, also the 9 minimum standards: (Ensure Adequate Storage Capacity) of the General Discharge Permit. Evidence of spillover was present on the west side of the pit which was observed by Dave Bramble. The adjacent land and vegetation showed manure residue along with discoloration and signs of decay. The discharge appeared to flow over an embankment into the wetlands. These wetlands flow directly to the water infrastructure asset area, through a rip-rap channel, and into the Basin Run tributary, a state waterway. Manure pit #1 was also observed to be full. The remaining pits were stable, and no active discharges were observed while MDE was on site. An inspection of Strohmaier Farm by Dave Bramble and I also today revealed that its manure pit was also full.

Manure pit # 3 currently being pumped down for field injection. Pit #3 is at maximum capacity

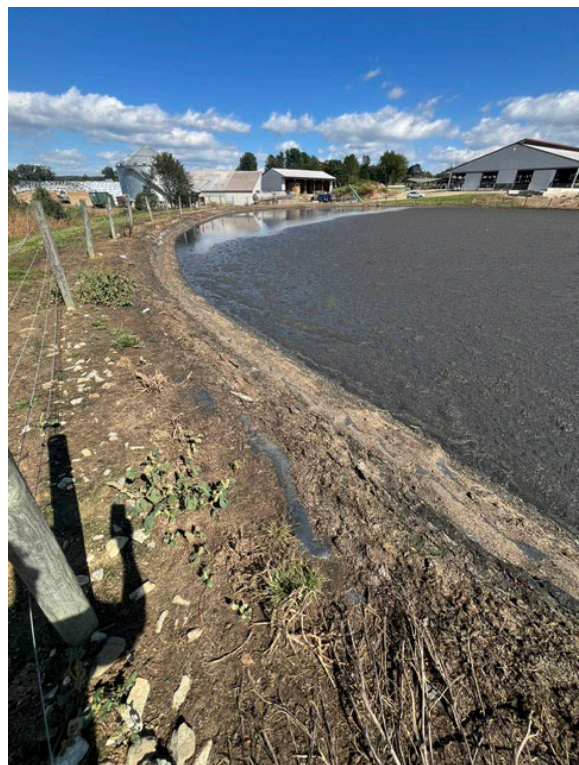
Manure pit # 3 shows evidence of a recent overflow

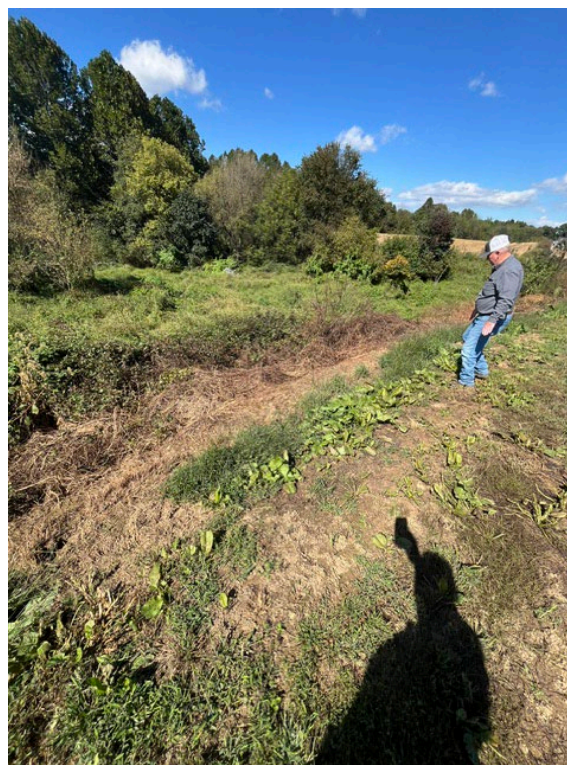
Overflow of manure pit #3 possibly went over the berm and down into the wetlands.

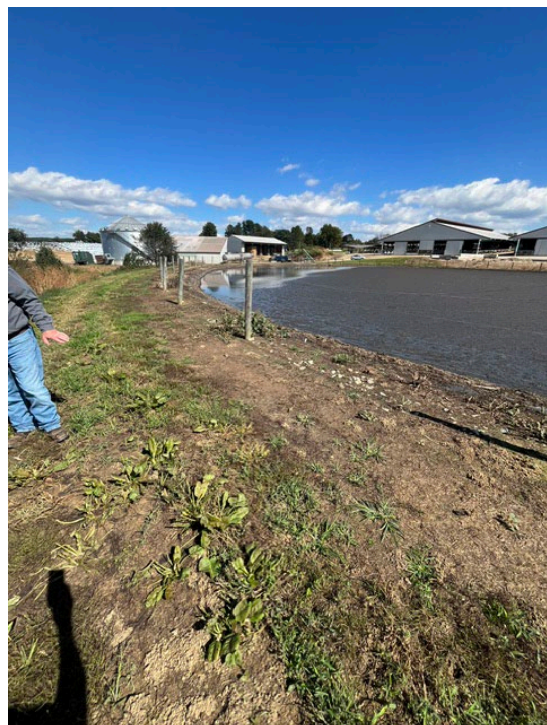
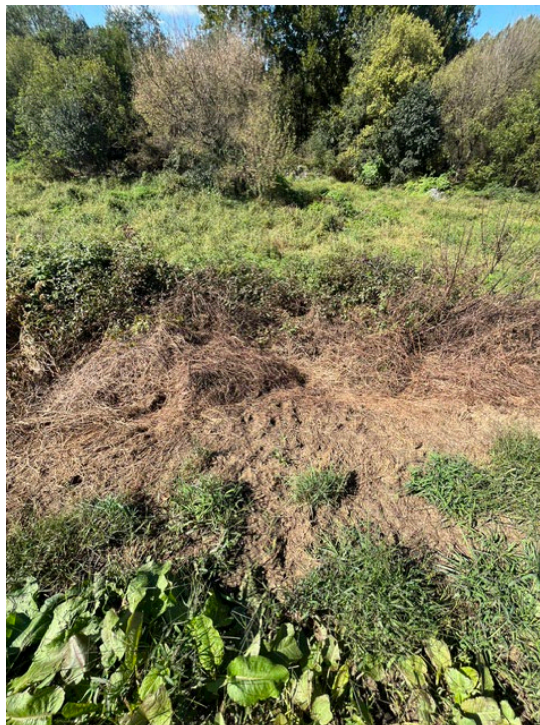
Manure pit #3 shows evidence of a recent overflow which went over the berm and down the hill into the wetlands, where it is likely to discharge. The dead and decaying vegetation, as well as the rills shows the path the discharge most likely took.

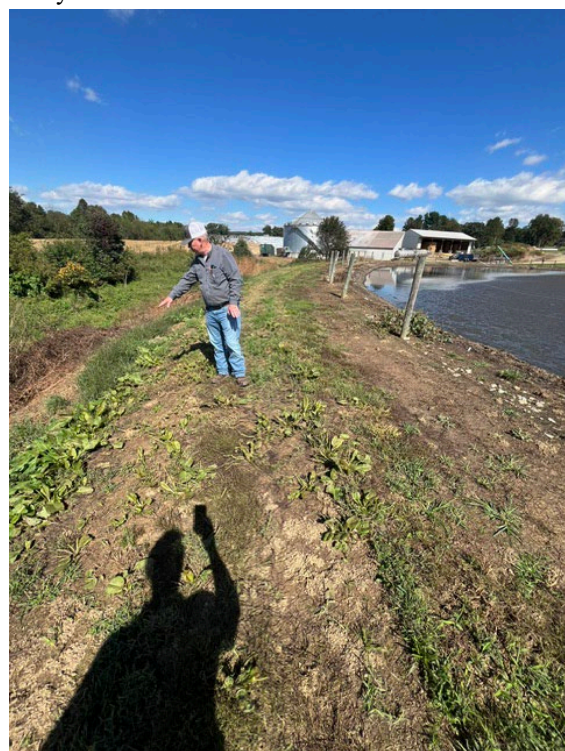
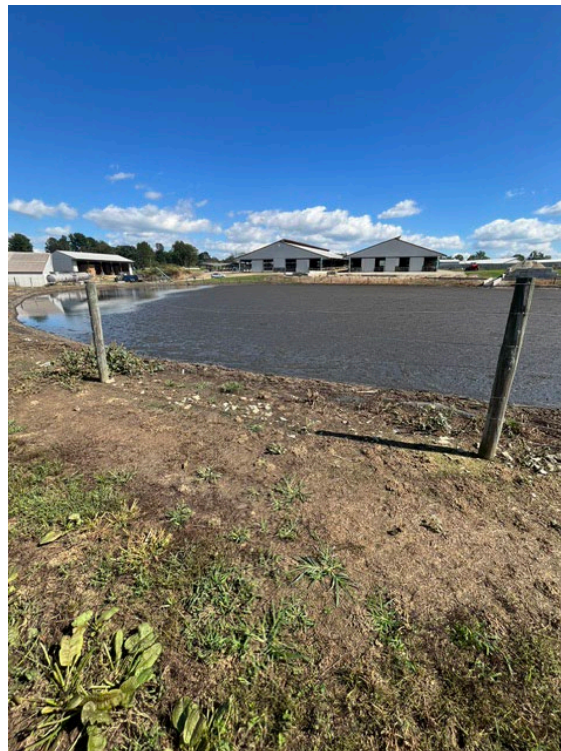
Manure pit #3 west side where the discharge is believed to have occurred, flowed over the pits edge, down the hill into the wetlands that flows directly to the stone rip wrap and into Basin Run.

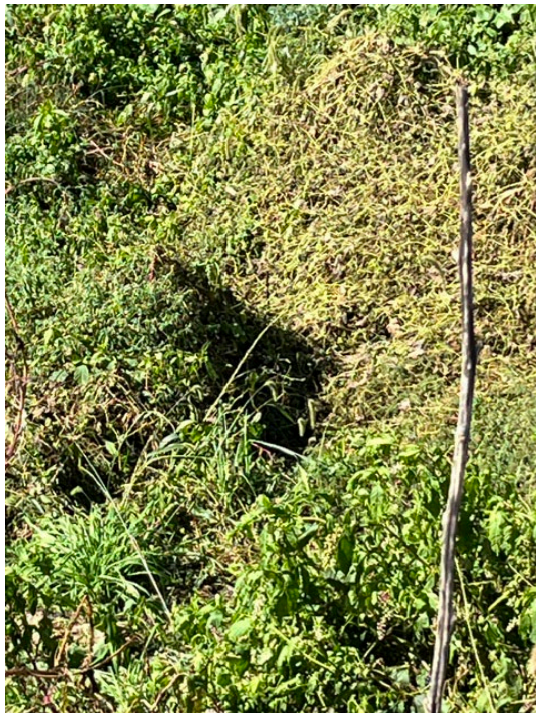
Black water – leachate pooling down the bottom of the hill where the wetlands start which is directly over the berm from manure pit #3 overflow spot

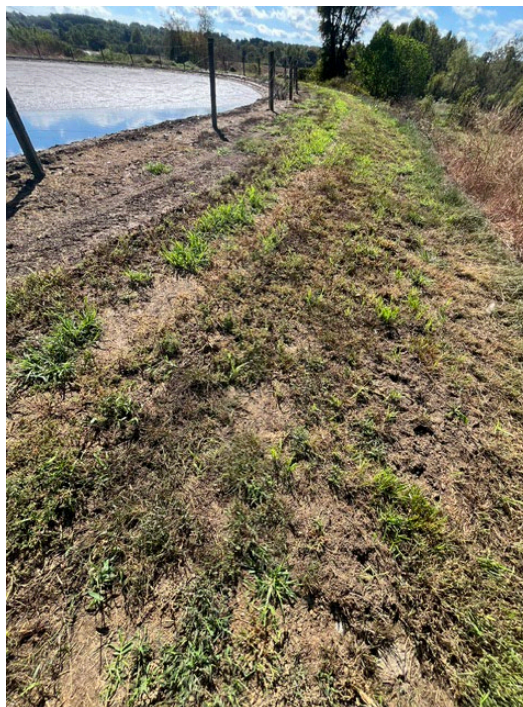
Manure pit # 3 – west side of the manure pit, which is the likely path the overflow took.

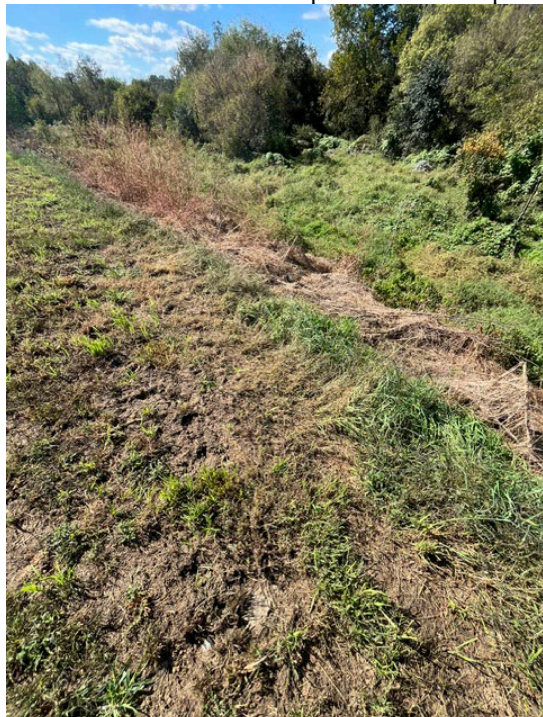
Dead or dying plant life showing the probable path that a manure overflow took from manure pit #3

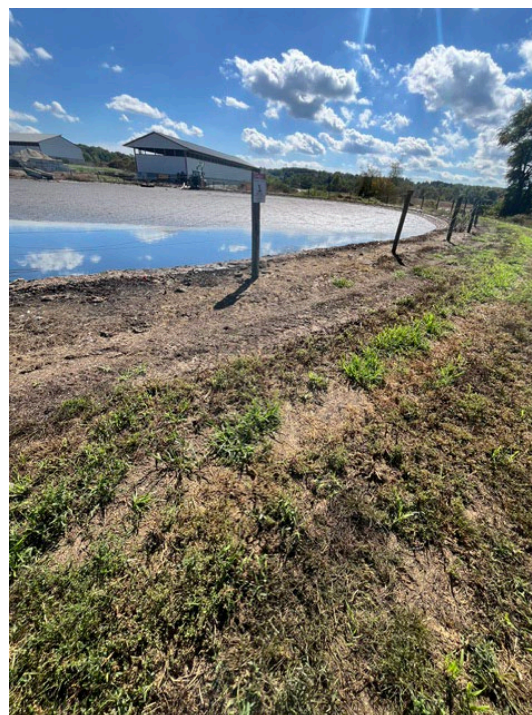
Manure pit #3 west side showing evidence of a previous overflow.

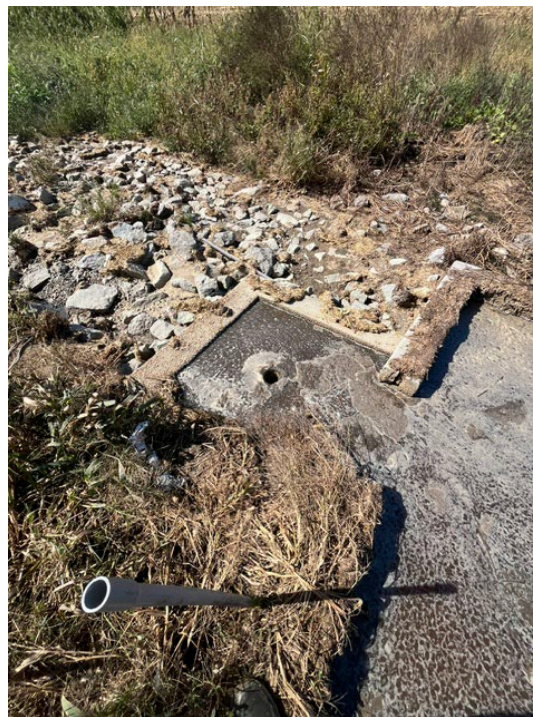
During October 1, 2026, I saw no changes to this corrective action, which has been continuously reported on for a year now. This was the same as October 1, 2026, where the perforated pipe located in the concrete collection bin was still clogged; therefore, additional runoff over the sides of the collection basin will continue to occur. Past inspections by me advised Kilby Farm staff to keep this pipe clear to allow the maximum amount of processed wastewater to flow into the collection tank. This was not done, and because of this, during a rain event this creates more of a position to likely discharge. (see photos).

Collection basin showing a clogged pipe which leads To the holding tank and is pumped into manure pit # 3

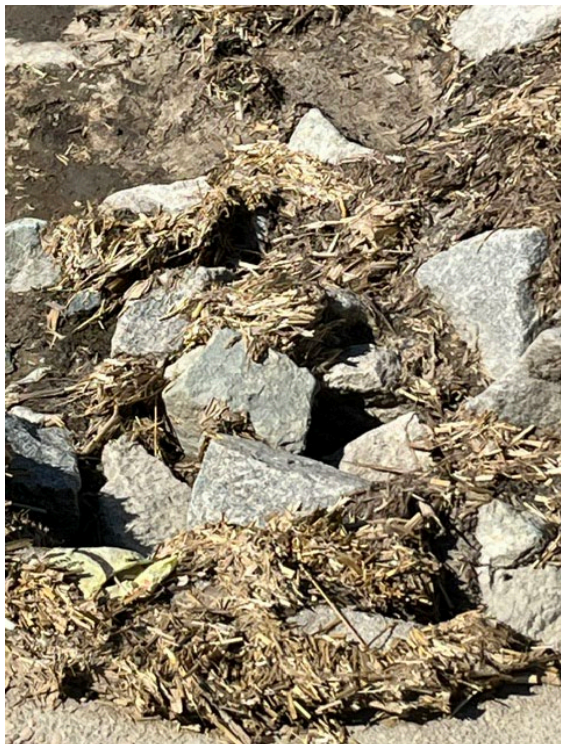
Chunks of silage and leachate which has overflowed from the catch basin. The catch basin is clearly clogged, which allows a discharge over the sides and into a rock channel which leads to the wetlands which leads to Basin Run.

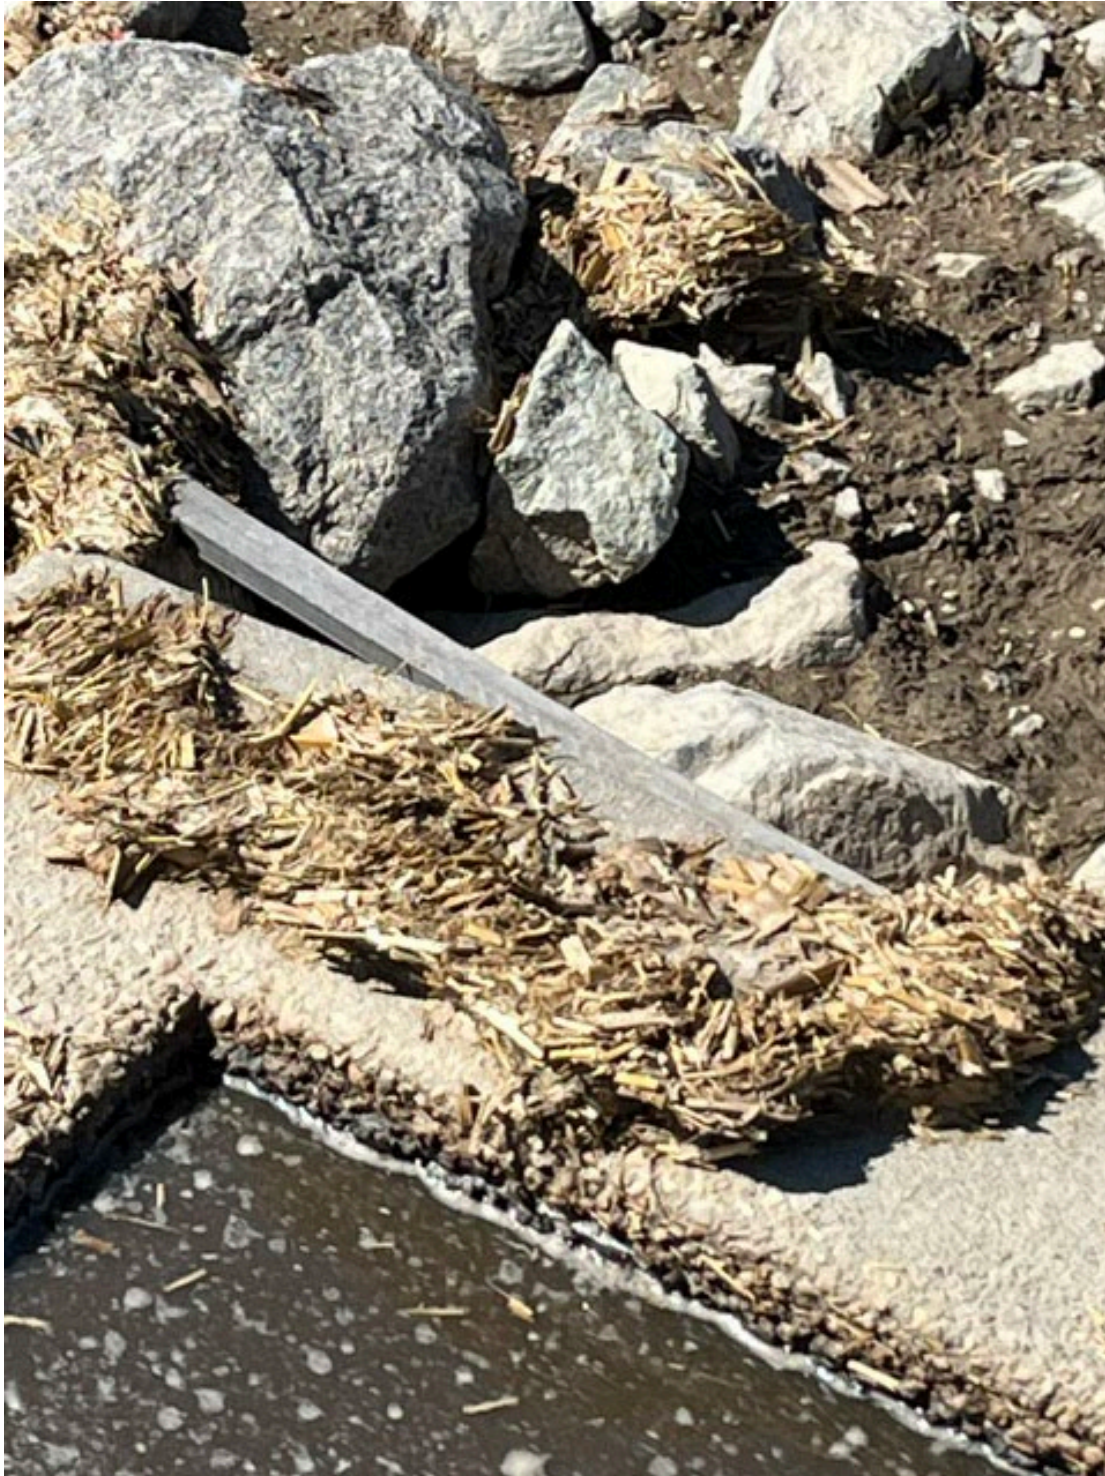
Top right corner of the leachate catch basin which had recently spilled over. On top of the basin wall is Silage which is a known pollutant.

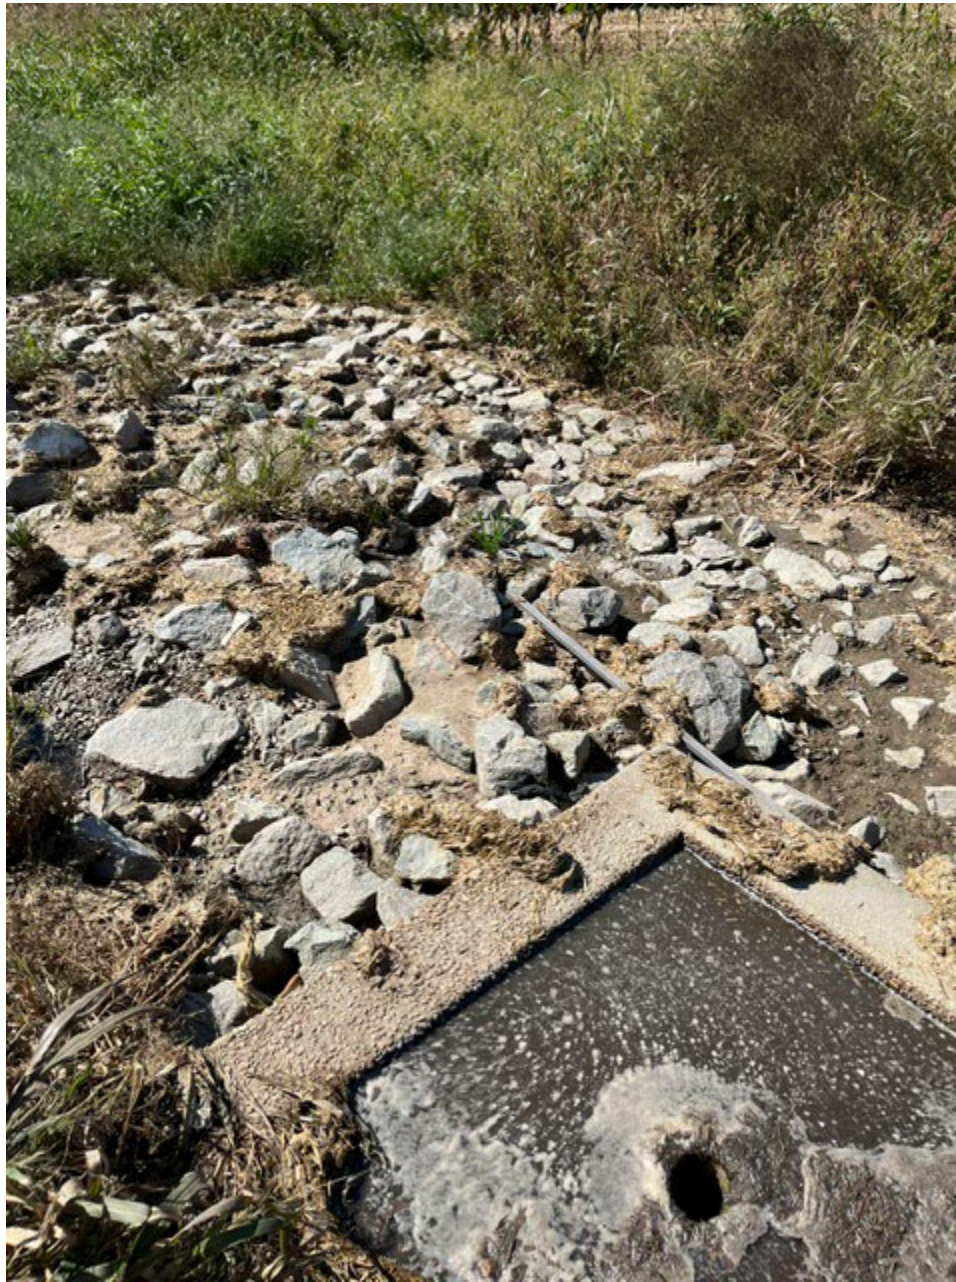
Wider view of the collection basin where silage and leachate has overflowed a clogged system. You can see where chunks of silage has washed over the basin and down the rock channel towards The wetlands and eventually to Basin Run tributary, a waterway of the State of Maryland.

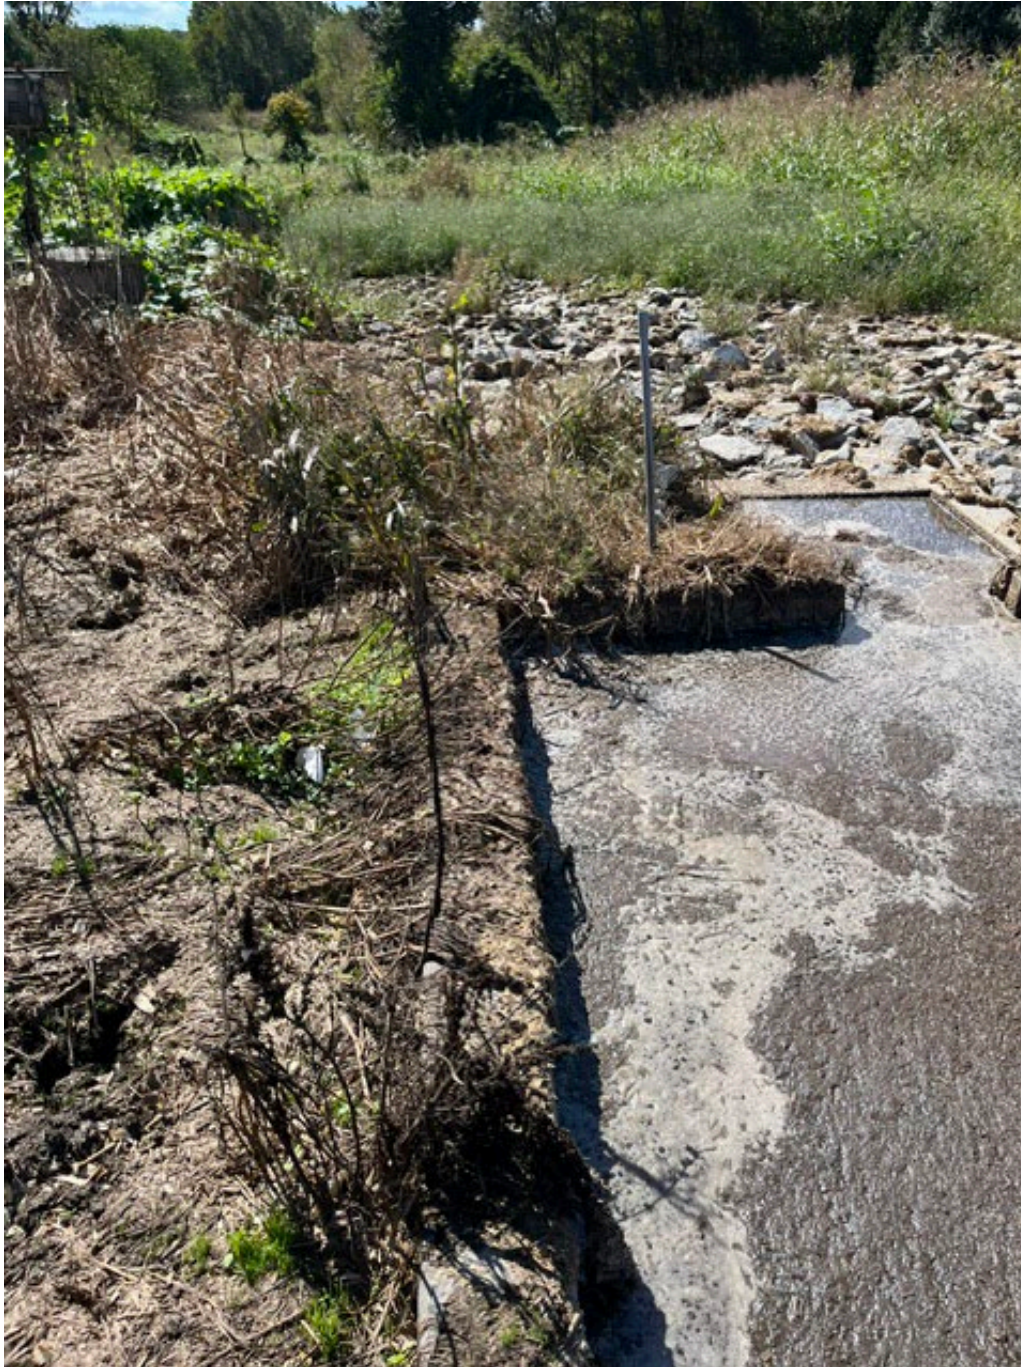
An overview of the silage – leachate collection system. The system is currently clogged and a significant rain event is forecasted for Sunday, October 11, 2026, which if still clogged will most likely cause a significant discharge. Of known pollutants into the wetlands and then into Basin Run tributary, which is a waterway of the State.

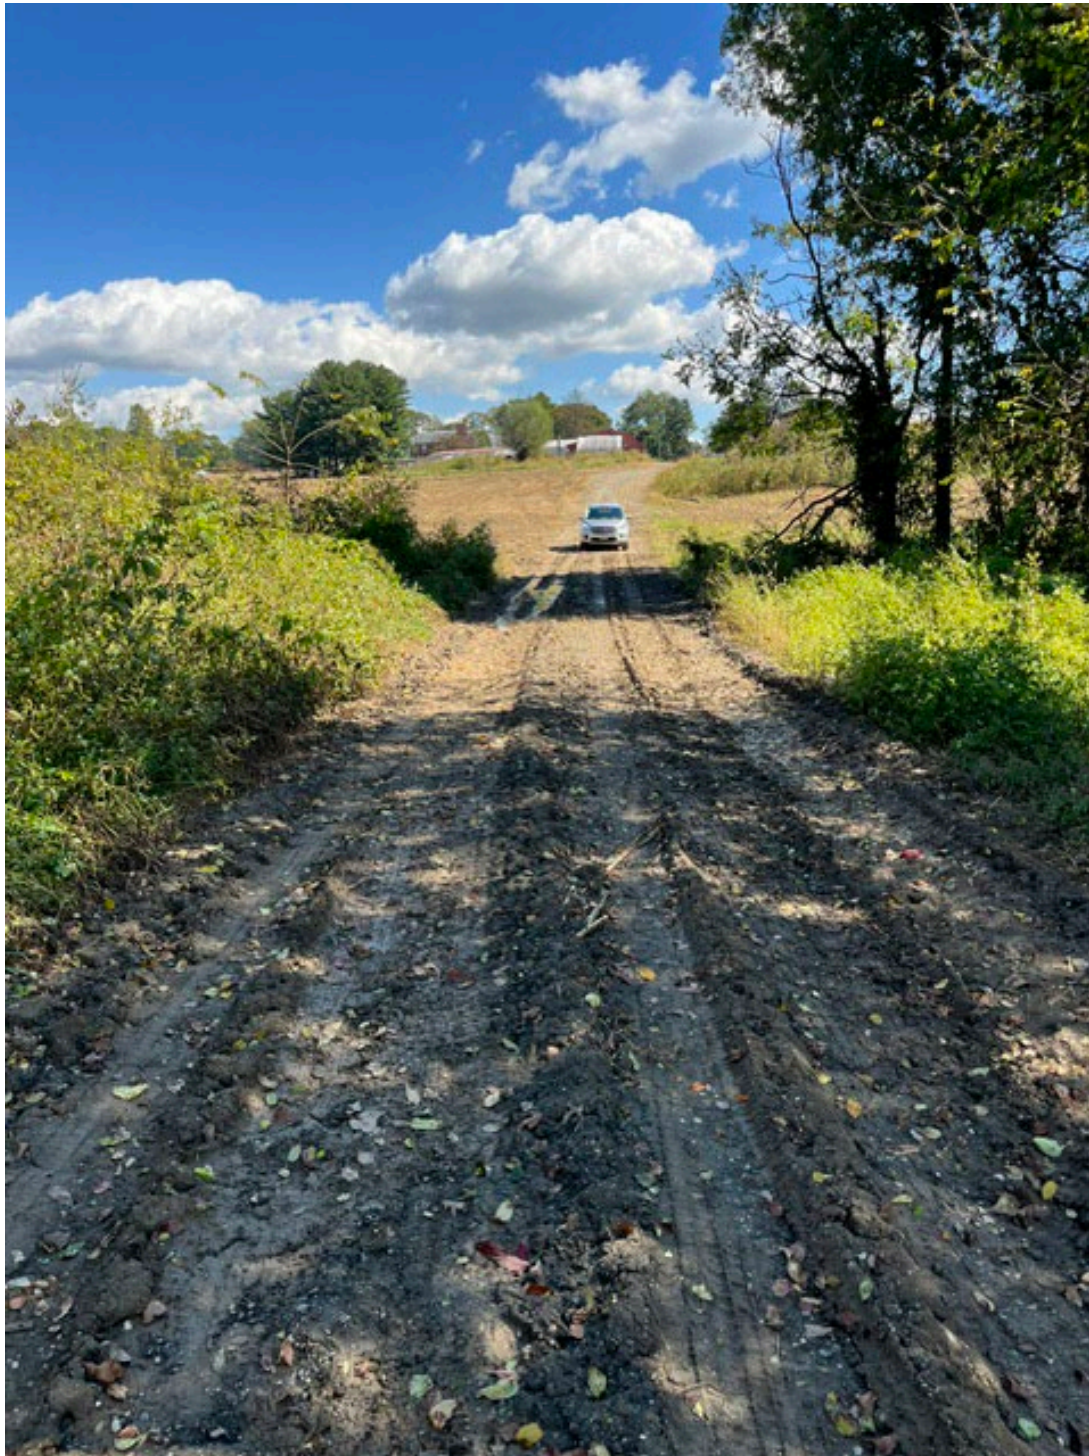
This is the pathway over the creek which comes down from the northwest and according to Mr. Flahart is polluted. Notice the farm fields in the background which are farmed by Kilby Farms, the fields sloop downhill towards the “creek” area. Notice the wet residual liquid manure spilled or haphazardly deployed during the injection process. There has been no significant rain reported since September 26, 2026, which makes it unlikely that the moisture is due to a rain event.
